Clinical Case

- Clinical Situation:
Tooth 12 presenting extensive root decay with peri-apical infection

- Restorative Solution:
Extraction, followed by immediate implant placement, immediate loading, provisional crown on a universal abutment with "one-abutment-one-time" concept, and finalized with a ceramic crown

Surgical products	Prosthetic products
CM Drive Acqua 3.5 x 13mm	CM Universal Abutment 3.3 x 6 x 2.5mm

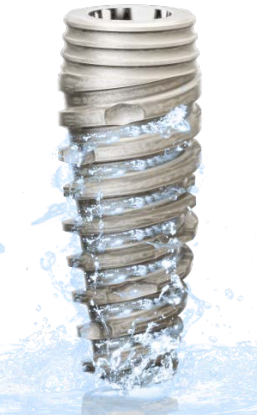
CM Drive Acqua

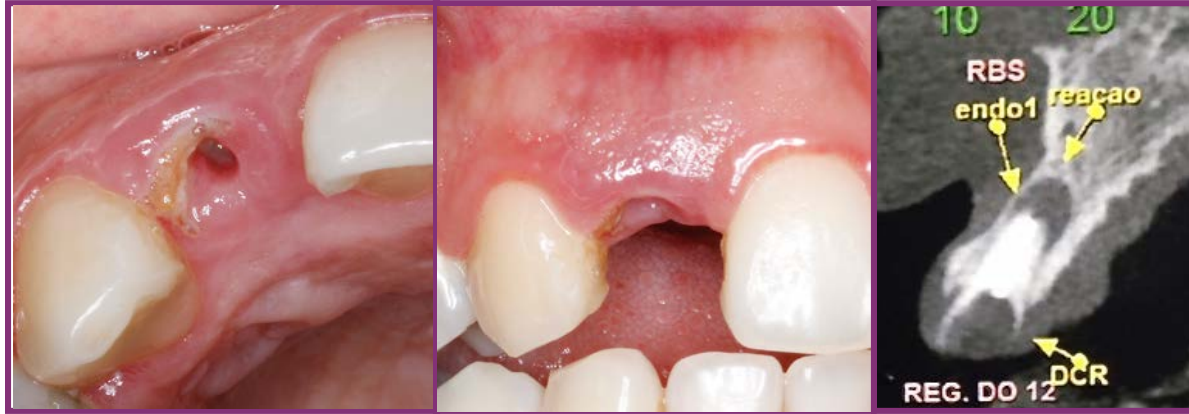
Initial Situation

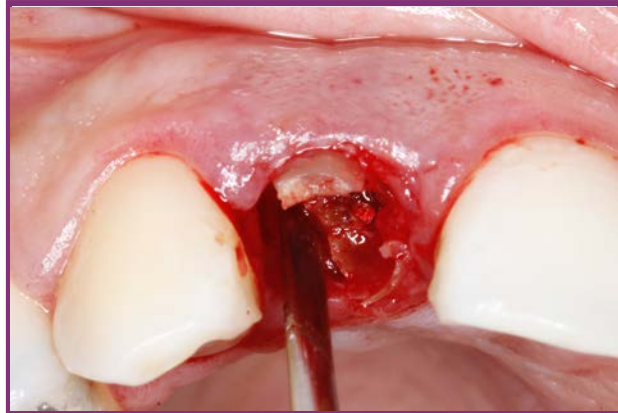
*Minimally traumatic extraction
with periosteal*

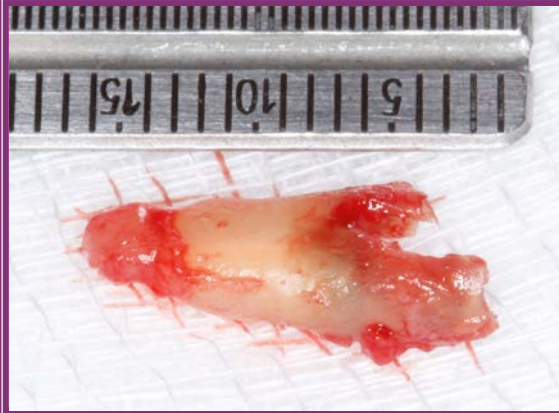
Extracted root

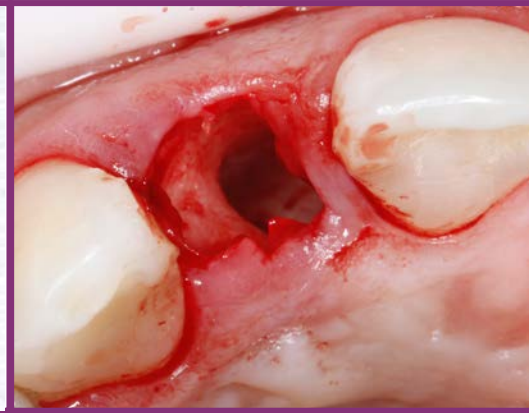
*Extraction site
- mesially oriented*

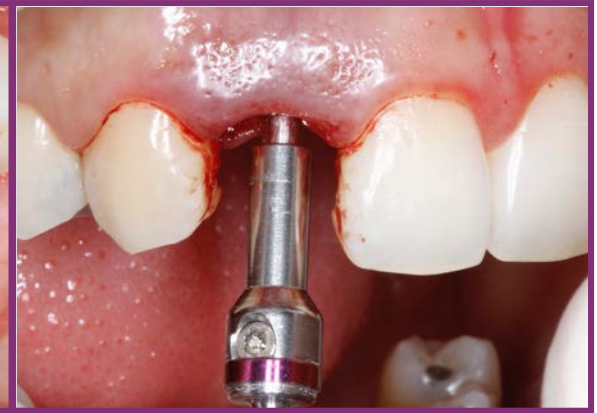
*Implant bed preparation
- drill extension*

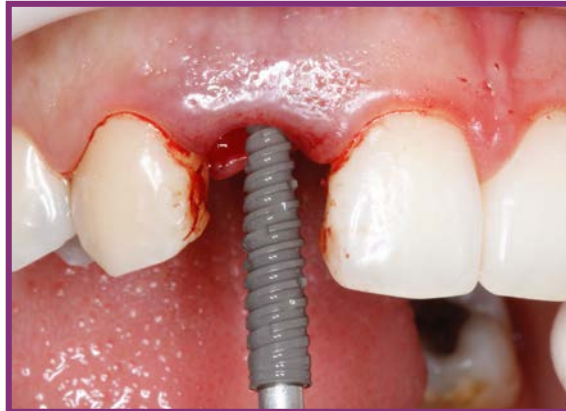
Implant placement

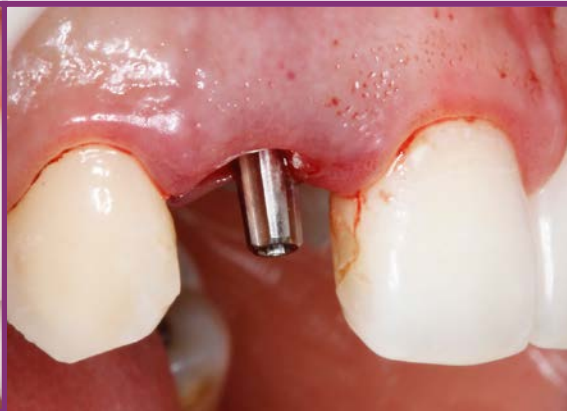
Abutment in place

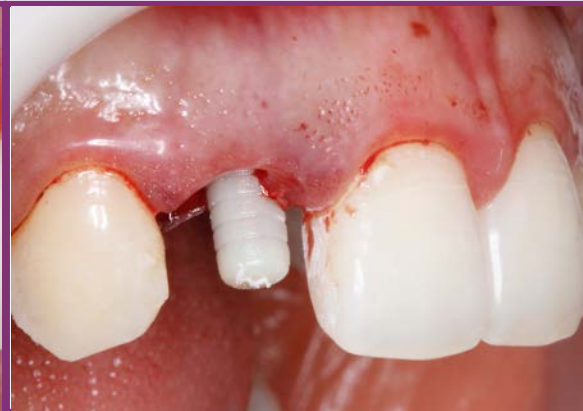
Universal Abutment provisional coping in place

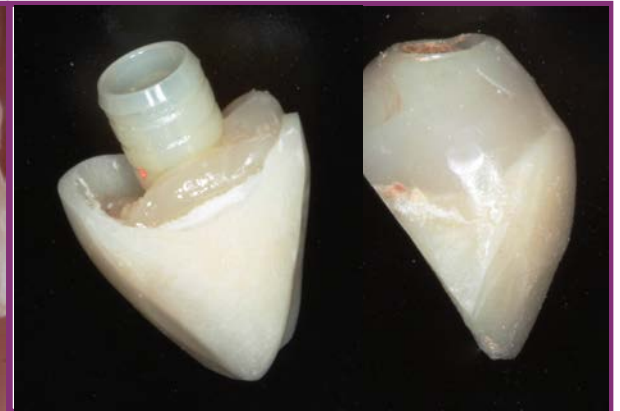
*Provisional universal abutment coping
captured into prefabricated crown shell*

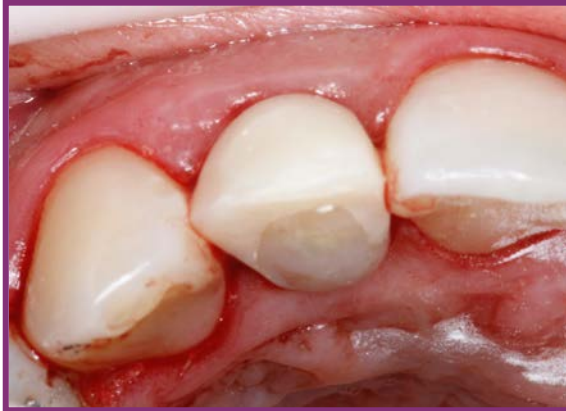
*Provisional restoration in place
- occlusal view*

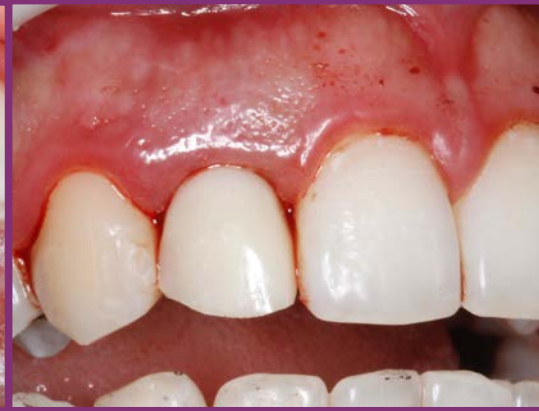
*Provisional restoration in place
- labial view*

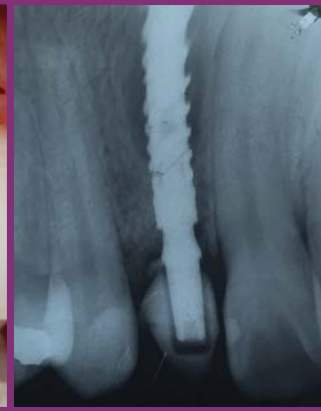
Immediate post op. x-ray

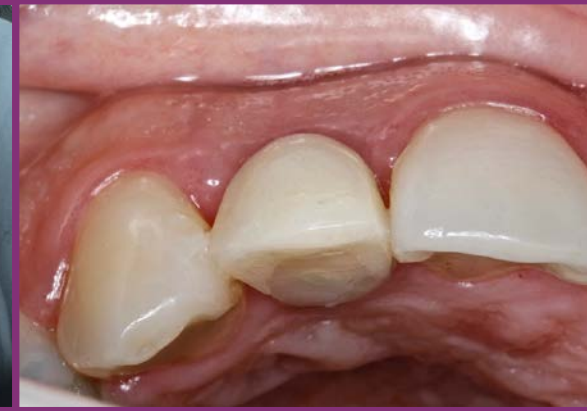
*Provisional restoration occlusal view
4 months after surgery*

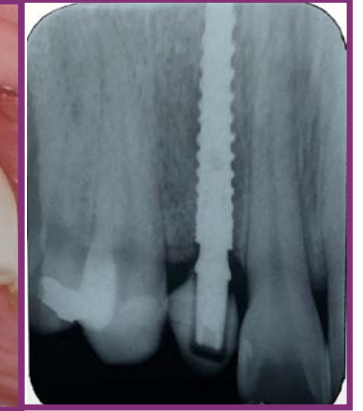
*3 month post provisional
restoration X-ray*

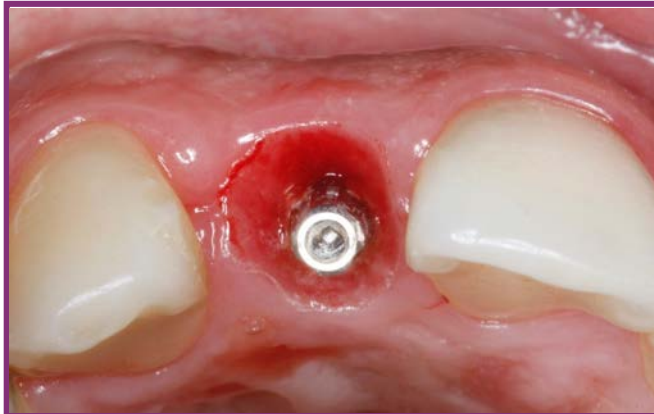
Great emergence profile 4 months after surgery

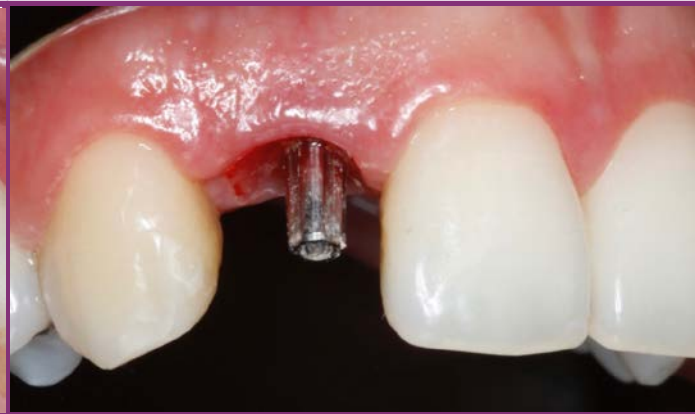
Stable soft-tissue contour 4 months after surgery

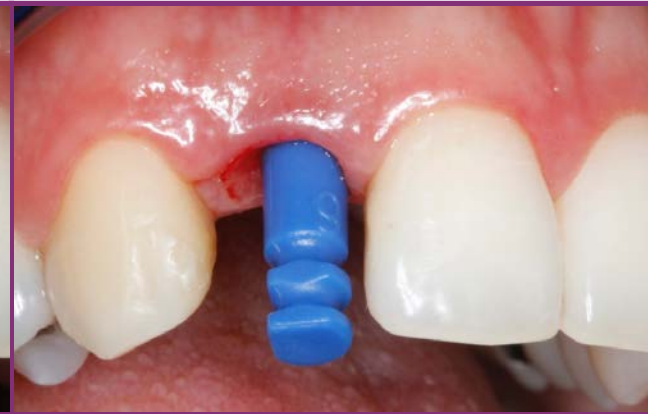
Universal abutment impression coping in place

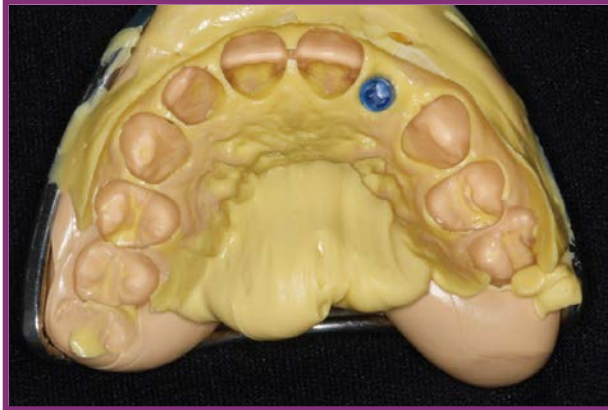
Impression taken

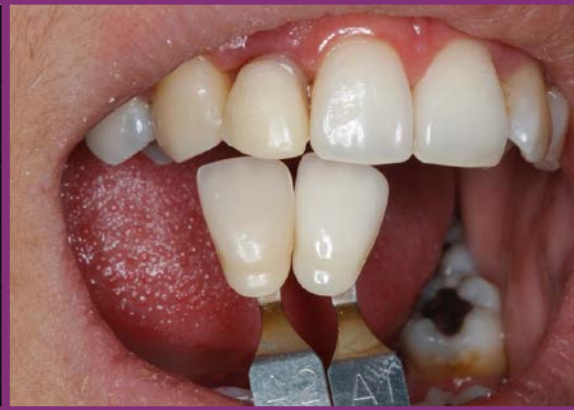
Shade selection

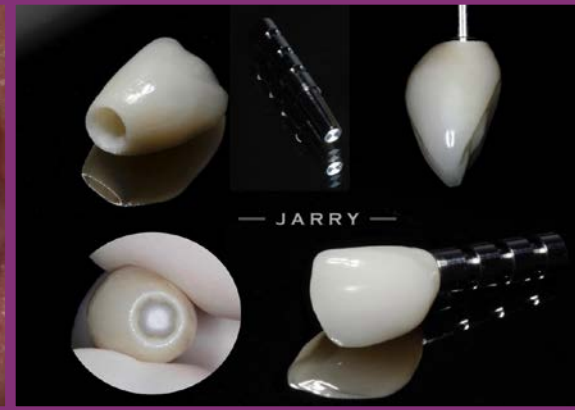
Porcelain applied to Zirconia coping

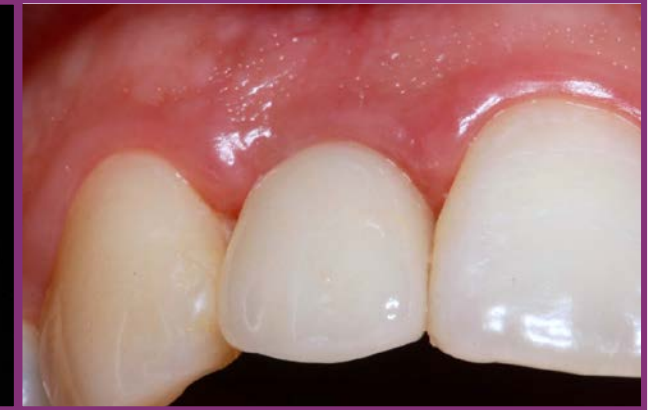
*Final restoration in place
Close-up*

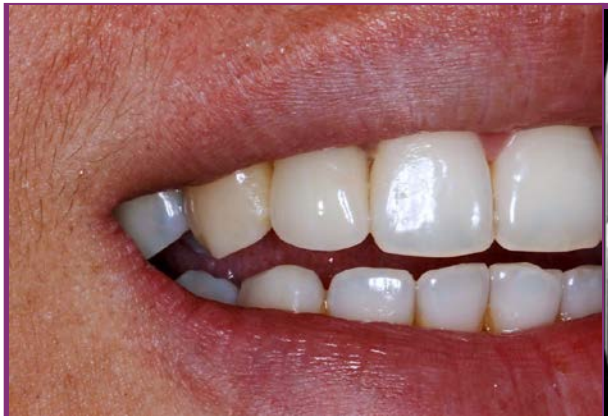
*Final restoration
Extra-oral lateral view*

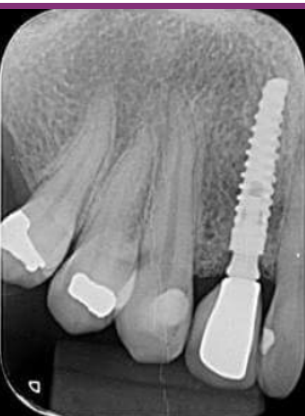
2-year follow-up X-ray
