Clinical Case

CM Drive Acqua

- Clinical Situation:
Traumatic avulsion of tooth 11 due to a road-traffic accident which also let to the 21 incisal edge fracture. Tooth 11 was not found.
An implant-supported prosthetic restoration was chosen.
The patient presented to our dental practice the day after the accident demanding an immediate solution the obliged us to operate her within a few hours.

- Restorative Solution:
Implant placement in support to an immediate zirconia/ceramic provisional crown, considering the esthetic needs of the patient and the short time available to produce it in laboratory

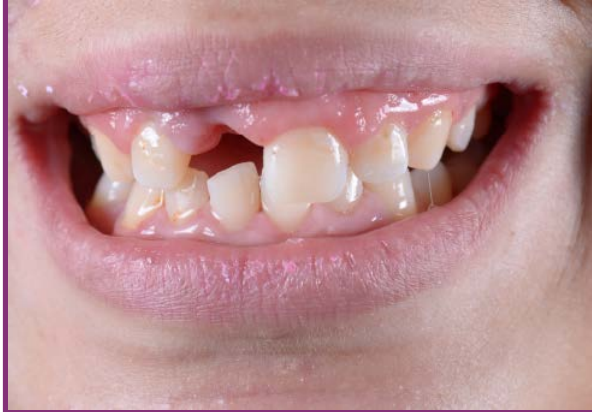
Pre-operative extra oral frontal view

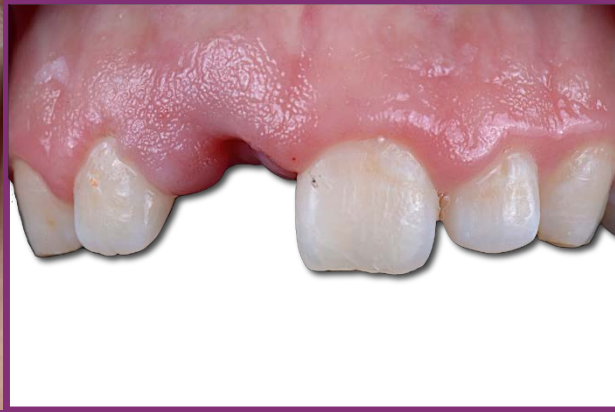
Pre-operative intra oral frontal view

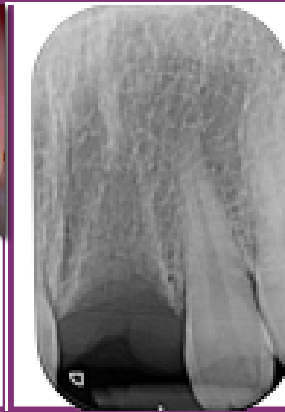
Pre-operative X-ray

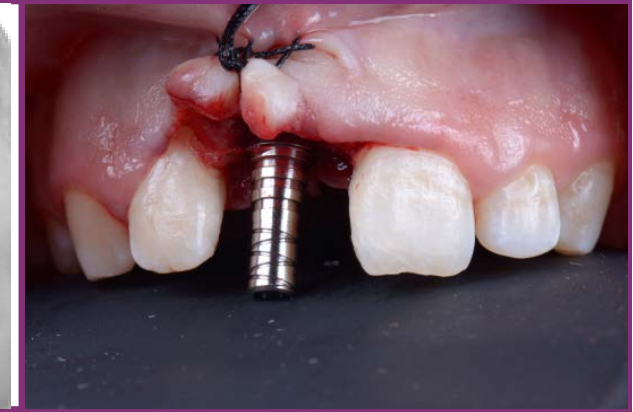
Abutment coping in place

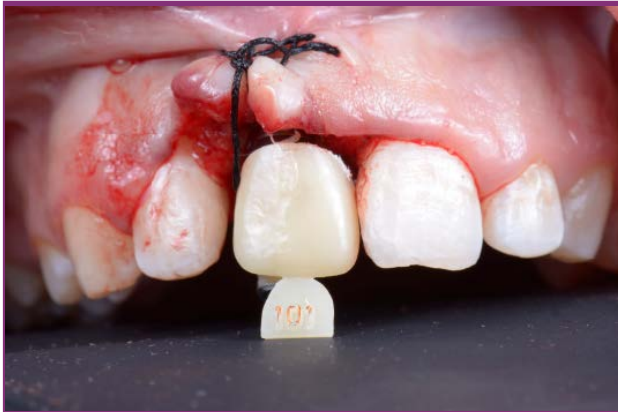
Immediate provisional restoration in place

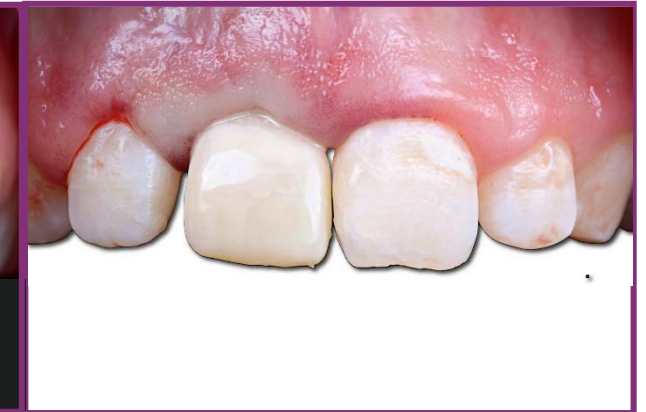
To improve the appearance of the provisional, super-colors and transparent paints were used directly at the chairside

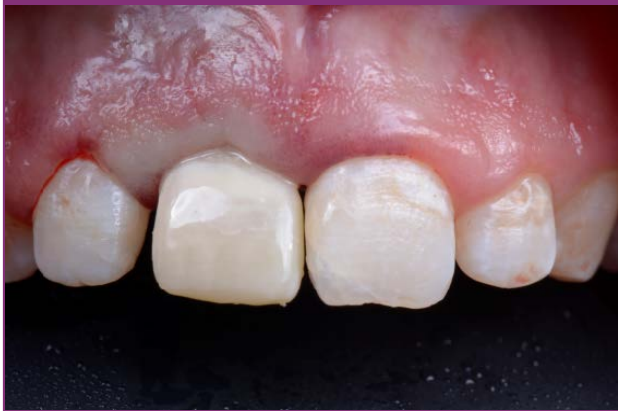
*Screw-retained provisional crown in position
Palatal suturing technique was performed to
avoid visible suturing knots in the buccal side.*

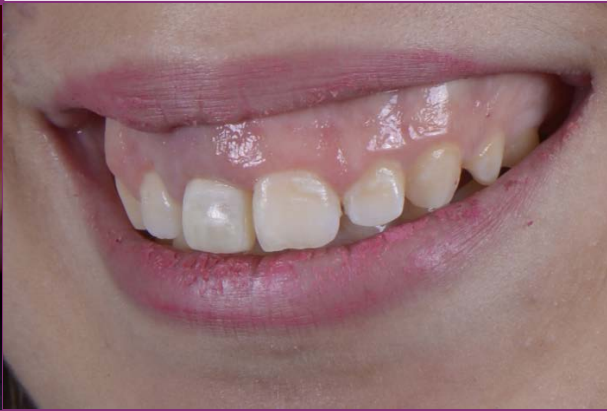
*Immediate post-operative
extra oral frontal view*

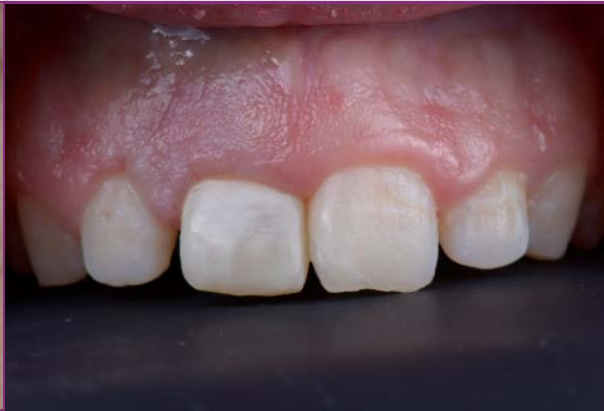
*Good soft-tissue healing
one month after surgery*

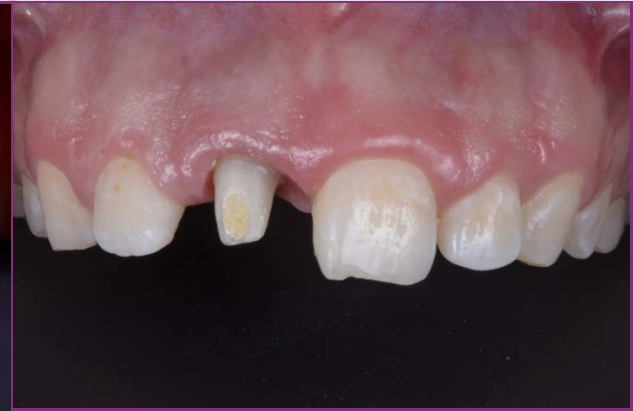
Zirconia coping on CM titanium base abutment

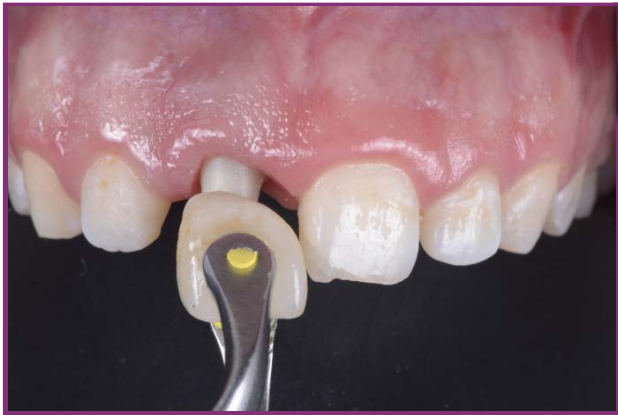
Crown seating

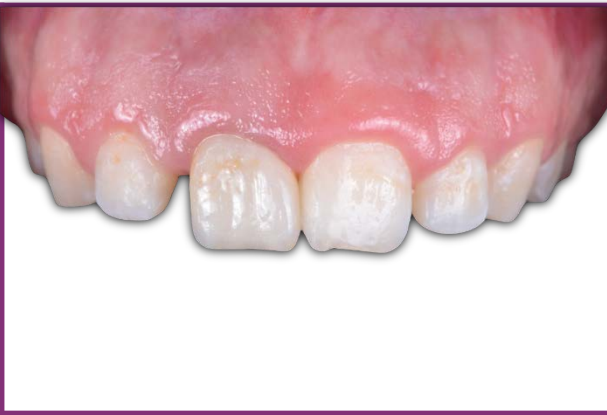
Final restoration 4 months after surgery

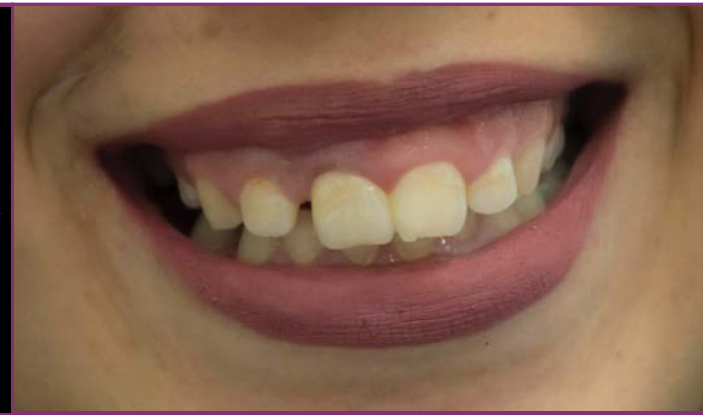
*1-year follow up
extra oral frontal view*
