CM Drive Acqua

- Profile: S.M.  
Female, 27 years old  
Rio de Janeiro, Brazil
- Clinical Situation:  
Fractured right central incisor with a critical buccal bone defect
- Restorative Solution:  
Extraction, followed by immediate implant placement, immediate loading, provisional crown on universal abutment with "one-abutment-one-time" concept, finalized with a ceramic crown

Summary	Immediate loading protocol	
Surgical Description	Maxilla	Anterior
	1 implant	Conventional
Restorative Solution	CAD/CAM	Zirconia ceramic crown

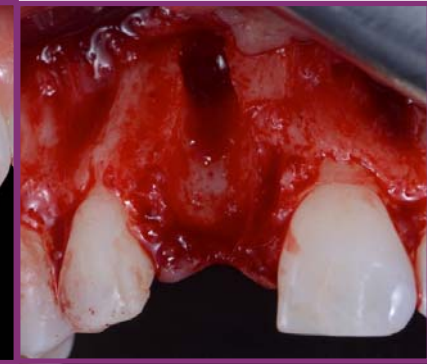
*Bone defect*

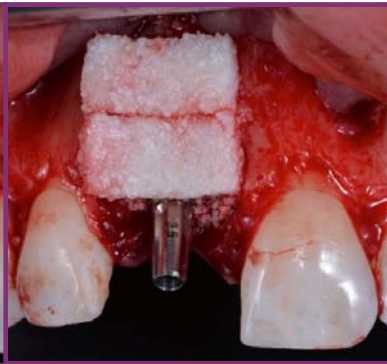
*Abutment in place  
Guided bone regeneration:  
Bovine+ Collagen Graft*

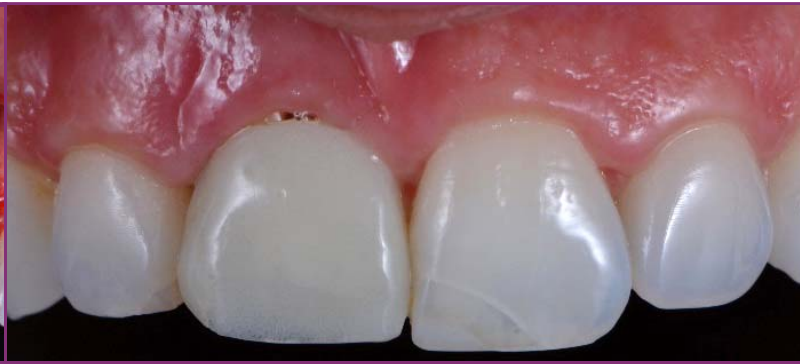
*Provisional restoration in place  
2 weeks after surgery*

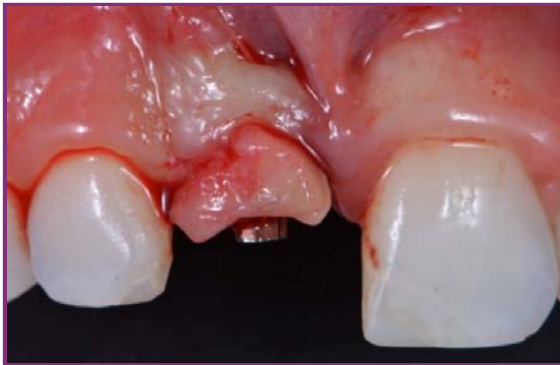
*Connective tissue grafting  
4 months after implant placement*

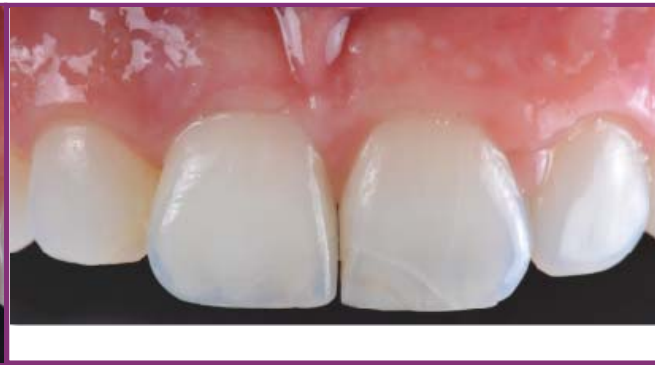
*Final Restoration*

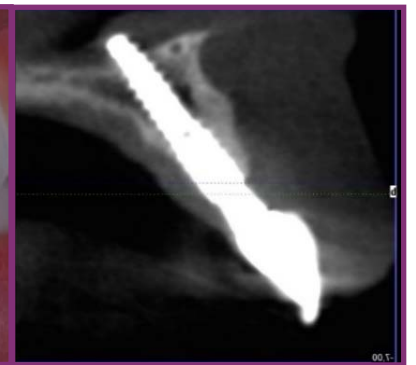
*13-month follow-up CBCT*
