CM Drive Acqua

Initial Situation

Clinical Case

- Profile: M. M.
Female, 45
Madrid, Spain
- Clinical Situation:
Dental fracture of tooth 21 and 22
- Restorative Solution:
Extraction, followed by implant placement and immediate temporization with full prosthetic digital workflow using titanium coping and customized zirconia coping

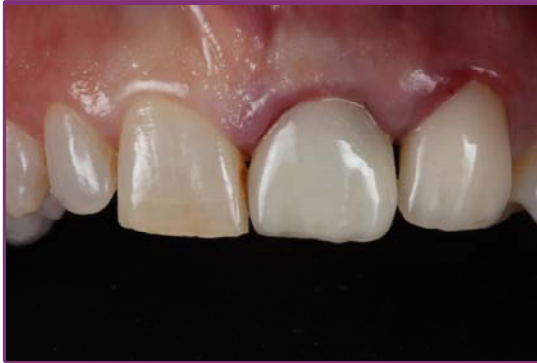
Intraoral frontal view

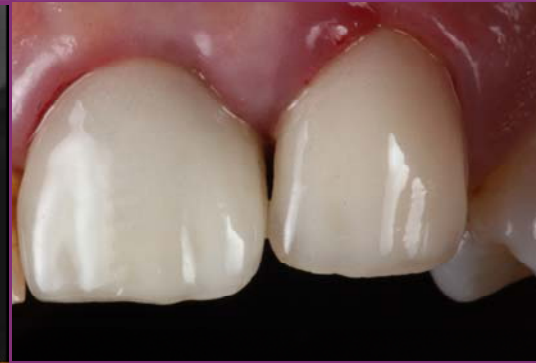
Pre-operative intraoral frontal view

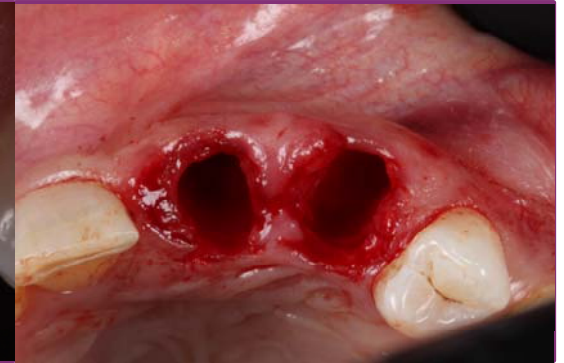
*Extraction sites
Socket that shows the intended correction of
dis-angulation*

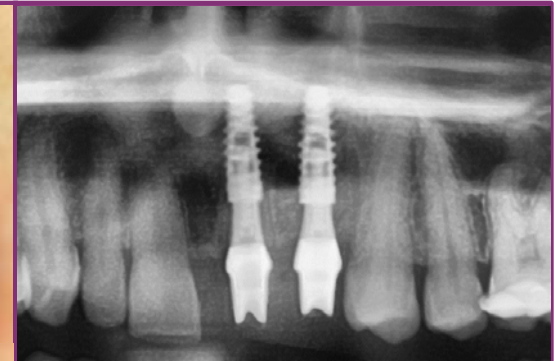
Post provisional restoration X-ray

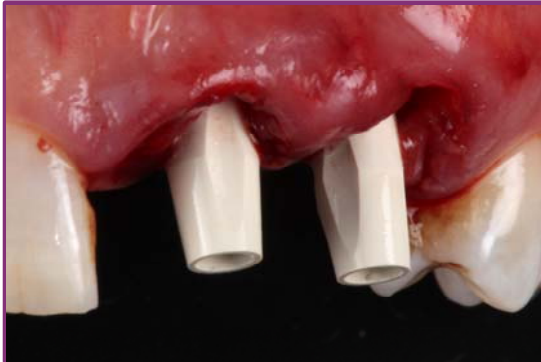
Intraoral scan body for digital impression

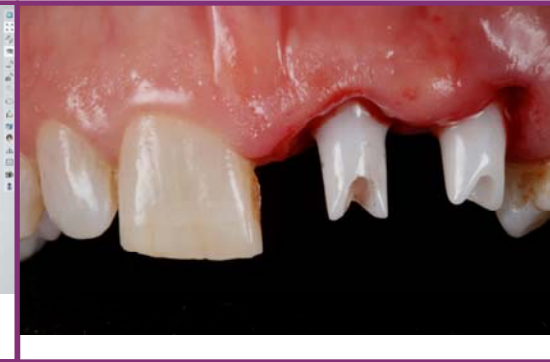
Abutment in place 4 hours after surgery due to zirconia sintering process

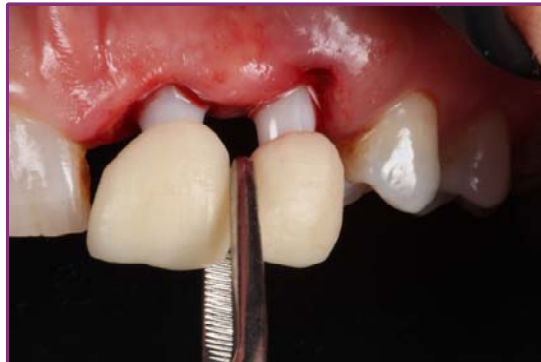
Immediate provisional restoration placement

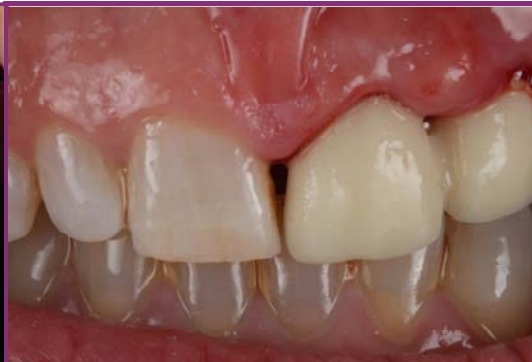
Immediate provisional restoration in position

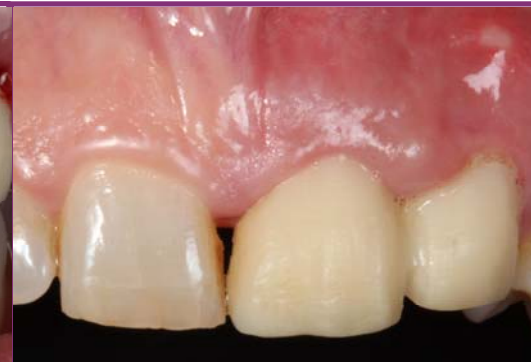
Good soft-tissue healing 4 days after surgery

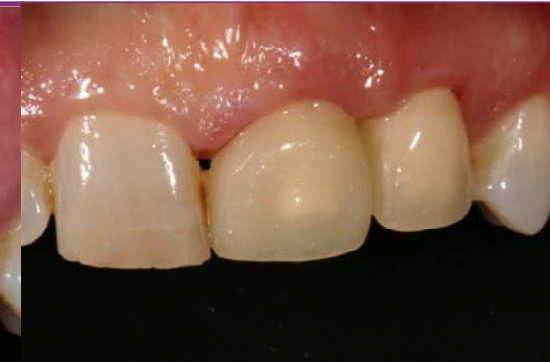
Adjusting the provisional crowns to fit the best emerging profile 6 weeks after surgery

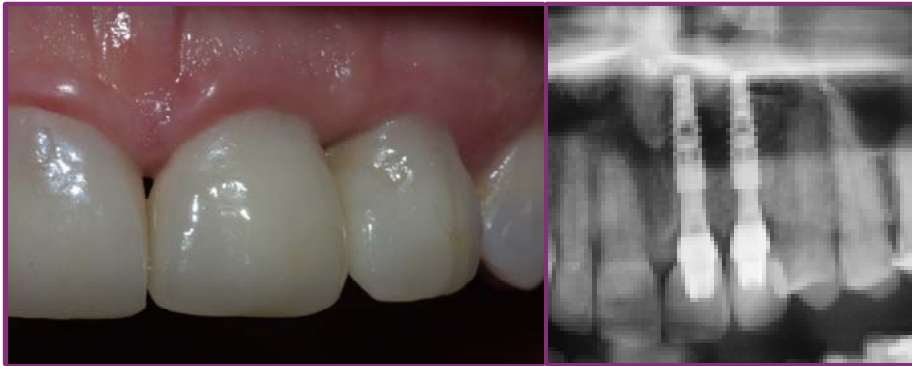
*Final restoration
1 year after surgery*

1-year follow-up X-ray
