# Clinical case

*HE Zygomatic*

Summary	Immediate loading protocol	
Surgical Description	Maxilla	Anterior
	4 Zygomatic implants (Maxilla)	Non guided surgery
Restorative Solution	CAD/CAM	Cobalt-chromium bar, Resin restoration

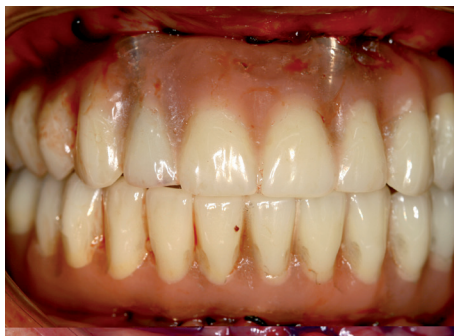
**4. Immediate provisional restoration in place**

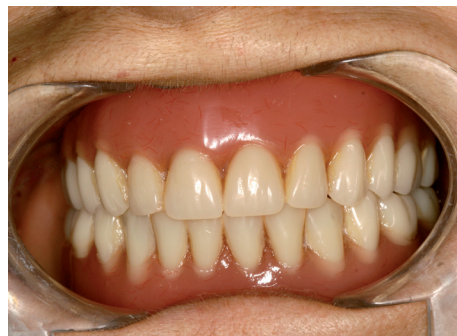
**5. Final restoration – frontal view**

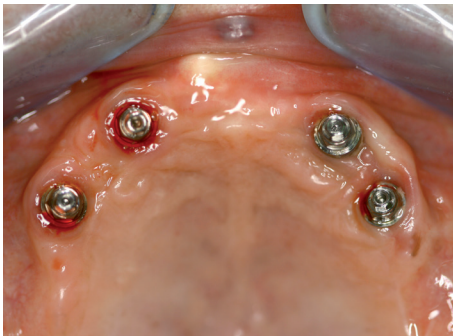
8. 1-year follow up – occlusal view

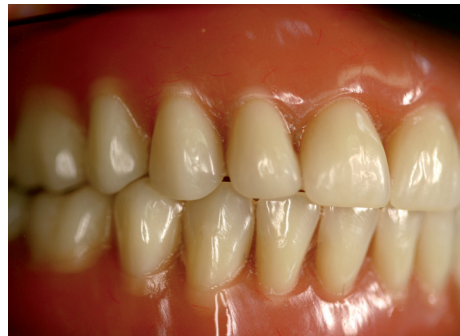
9. 1-year follow up – intraoral right-side

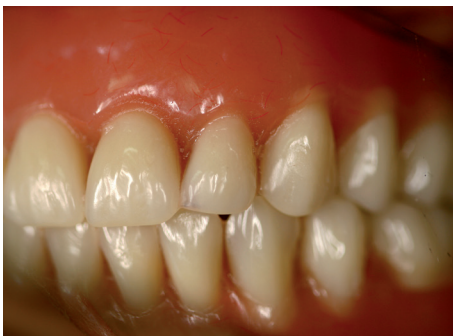
10. 1-year follow up – intraoral left-side
